IN THE UNITED STATES DISTRICT COURT FOR THE
NORTHERN DISTRICT OF ILLINOIS
EASTERN DIVISION

THE BOEING COMPANY, a corporation,

**DECLARATION OF PAUL J. BOLDS-MOOREHEAD IN SUPPORT OF
THE BOEING COMPANY'S MOTION FOR RECONSIDERATION**

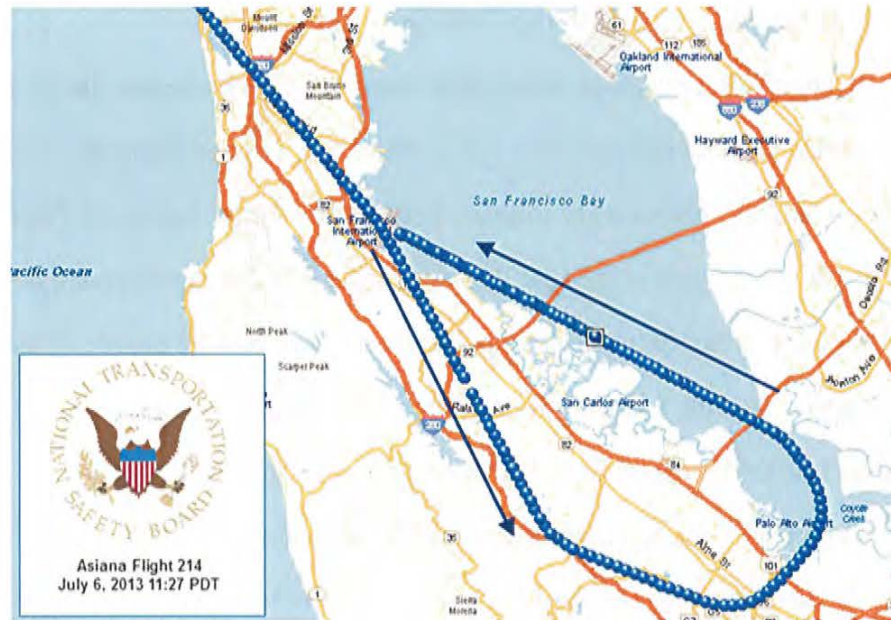
map below created by the NTSB shows Flight 214's approach path to SFO.¹ Flight 214's final approach leg was over San Francisco Bay.

¹ http://www.nts.gov/investigations/2013/asiana214/photos/130710_1_Flight_Overview1.jpg
